**HISTORIC BUILDING ASSESSMENT:
'PLAS SMART'
FR BOSTON LODGE WORKS
MINFFORDD
GWYNEDD**

*on behalf of Ffestiniog Railway Heritage Ltd
and the Festiniog Railway Company*

December 2011

ASC: 1388/FRC/1r

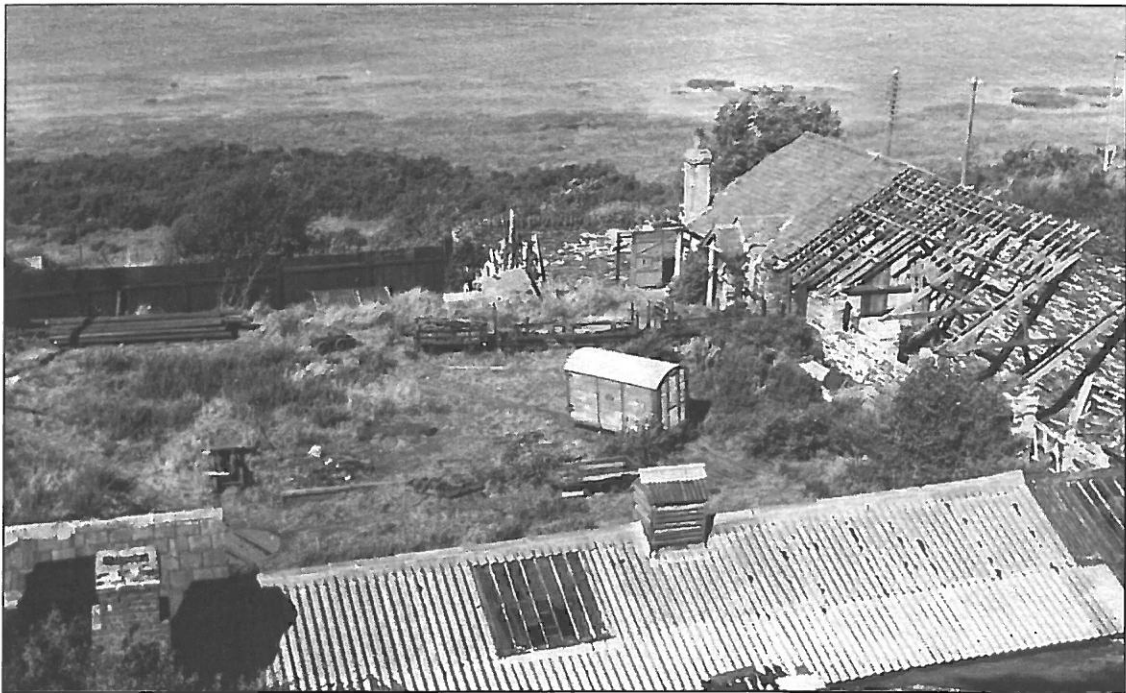
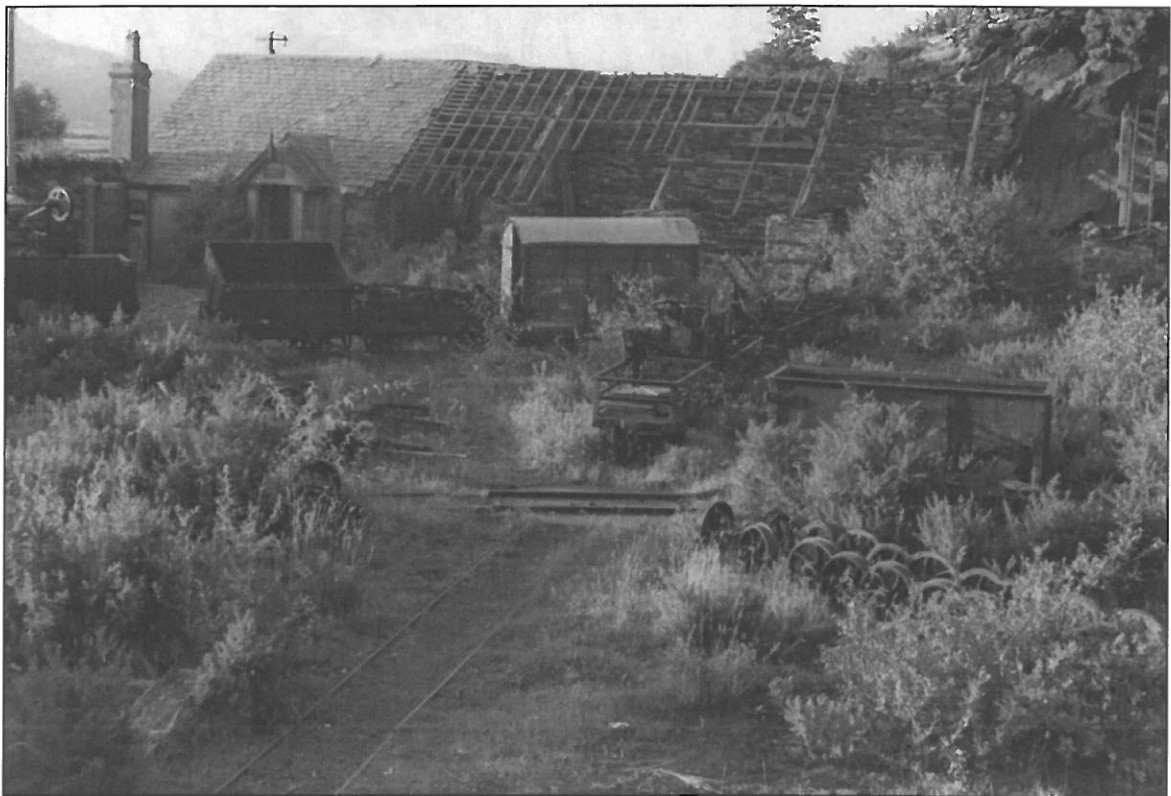
- 3.6 With the notable exception of Plas Smart, the range was derelict by 1954 (Figs 6 and 7), and was demolished in the early 1960s (FRM 20, Spring 1963, 10-16). The bay adjoining Plas Smart presumably lost its roof at this time, though the rear wall and archway remained for some time after. In the late 1950s or 1960s Plas Smart gained its present name, after volunteer and frequent occupant Ian Smart. The chimney was demolished sometime after 1984 (JLA notes). The opening to the sandpit in the adjoining bay was demolished when the present vehicular access to the works was constructed in the 1980s. Plas Smart is currently used as a store.

Figure 6: Top Yard from the cliffs to the east in September 1958 (*David Ronald*)

Figure 7: Top Yard from the south in July 1959 (*Dennis Corley*)

Examination of historic photographs (Figs 6, 7) it is apparent that the roof of Plas Smart was constructed as part of the overall roof of the adjoining range of buildings, with the principal rafters set at c.3.66m (12') centres.

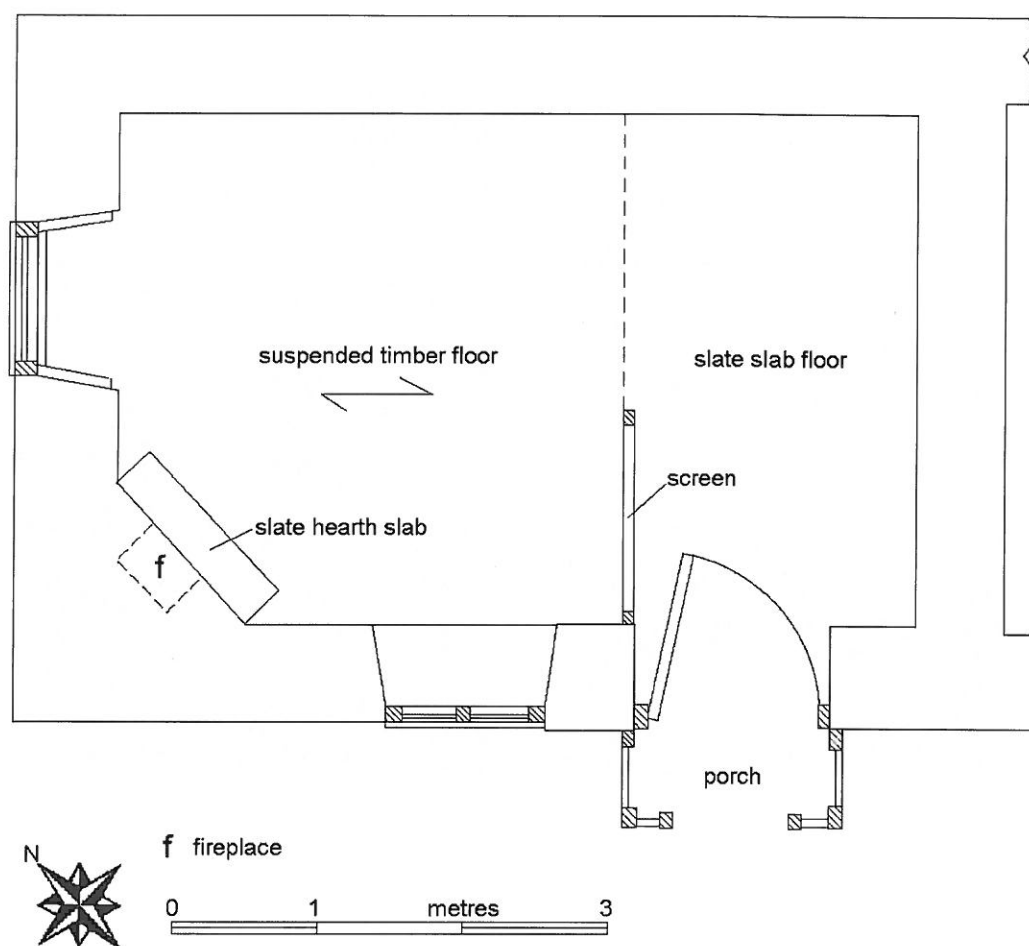
Figure 8: Plas Smart, floor plan (*scale 1:50*)

The walls of Plas Smart are constructed of coursed slate rubble, c.0.65m thick, with a pent slate roof, rising to the north-east. The building measures $6.88 \times 4.84\text{m}$ (22'6" \times 15'10"), with a porch projecting c.0.7m (2'4") to the south-west (Fig. 8). The north-east (rear) and south-west (front) walls are cement rendered (Figs 9, 10), and the north-west wall (Fig. 11) is roughly pointed. All the walls appear to be of one build, except at the east corner, where the south-east wall is butted to the rear wall. It is possible that other butt joints may be obscured by external rendering and internal plaster. Projecting wall stubs to the south-east indicate that the building was originally part of a longer range (Fig. 12). This suggestion is reinforced by the survival of a principal rafter, evidently for a south-eastward continuation of the roof, between the two stub walls. The entrance to the building is to the south-west, through the aforementioned porch (Fig. 13). To the north-west of this is a 4-light casement window overlooking the Top Yard. In the north-west wall, an 8/8 sash window overlooks the main line. The porch, which is a later addition to an existing gablet above the entrance, is constructed in timber, with open lattice side walls and a gabled slate roof. The wooden finial on the porch gable, present on photos of the late 1950s (Fig. 7) has been replaced with a poor modern imitation. It is evident that there was originally a chimney rising above the west corner of the building. This has since been removed, and slated over. The roof has a steep pitch, c.35°, and is slated. It ends flush with the north-west wall: at the south-east end, L-section metal flashing strip covers the truncated roof edge.

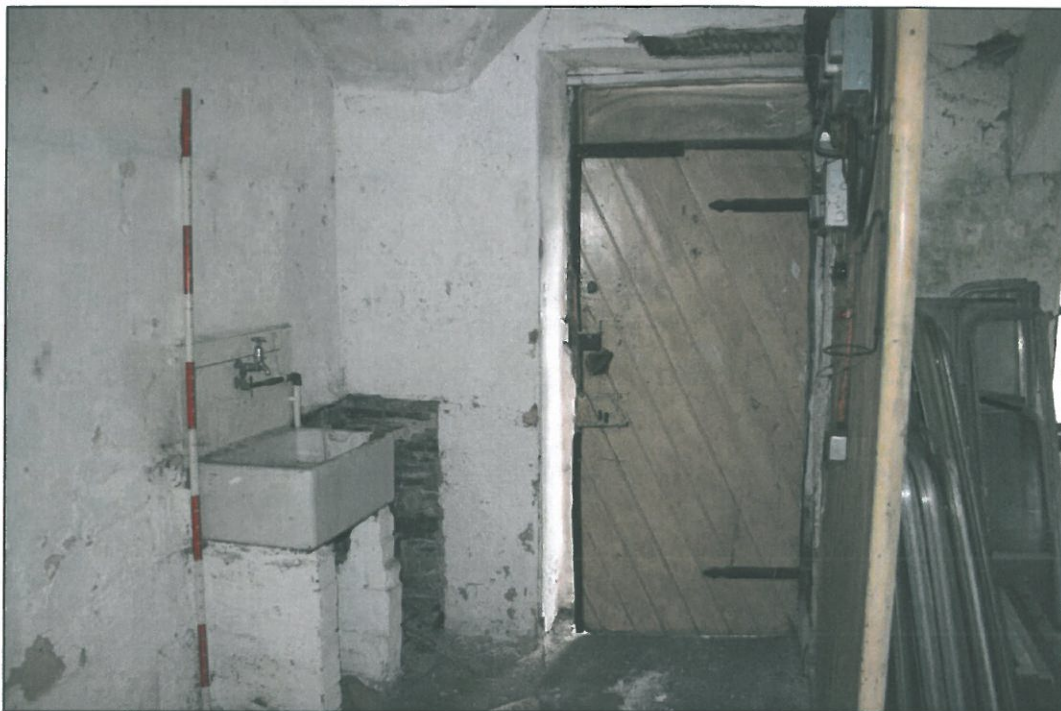
Figure 14: Lobby, looking south-west

Internally, the building measures $5.38 \times 3.42\text{m}$ (17'4½" \times 11'1½") overall, comprising two distinct areas. To the south-east, inside the entrance, is a lobby area c.3.42 \times 2.20m (11'1½" \times 7'2¾"). This has a solid floor of rectangular slate slabs and roughly plastered south-east, north-east and south-west walls (Figs 14, 15). To the north-west of the entrance is a vertically planked timber screen 1.43m (4'8") long, dividing the interior of the building (Figs 15 & 17). The entrance door is vertically planked externally and diagonally planked internally, is mounted on two substantial strap hinges, and appears to be a 19th-century fitting. The large handle may also be original, though the latch that it operated has gone. The only other feature of note in this part of the building is a small 'Belfast' type hand basin, associated with modern plumbing, mounted to the south-east wall.

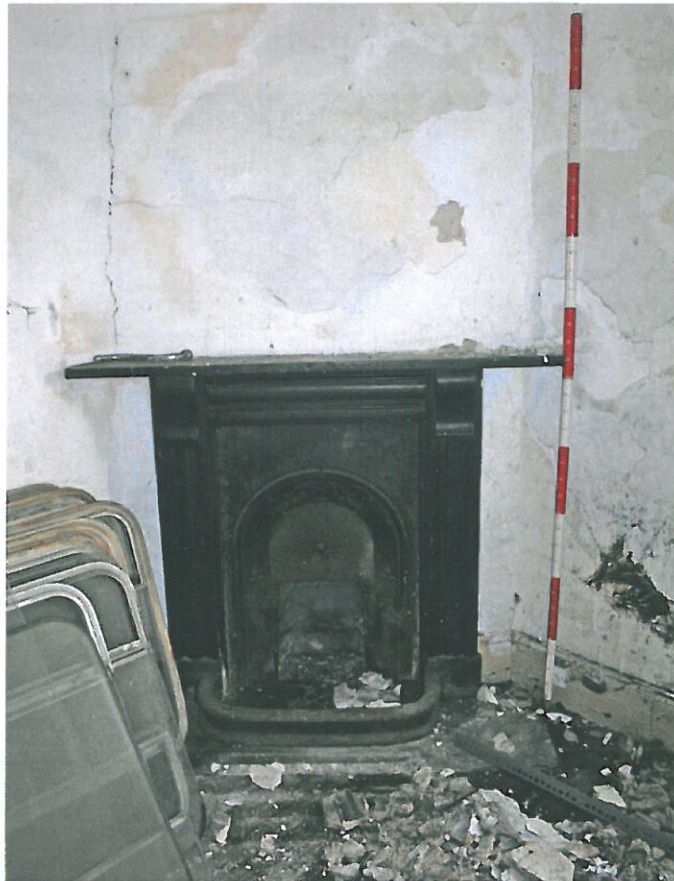
Figure 18: Office, fireplace in west corner

On the north-west side of the screen is the inner room or office (Figs 16, 17), $3.42 \times 3.18\text{m}$ (11'1½" \times 10'4¾"). This is distinguished from the lobby area by having a suspended timber floor, with NE-SW joists and NW-SE floorboards. In the angle of the west corner is a fireplace with a typical 19th-century cast-iron surround and integral mantel shelf, above a slate hearth slab (Fig. 18). In the south-west wall is the 4-light casement window, almost certainly a modern replacement, set in a splayed opening with a deep sill. In the north-west wall a second splayed opening contains the 8/8 sash window with folding 3-leaf panelled shutters, almost certainly original. Some plain skirting boards remain on the north-west wall.
